329502

April 23, 2014

**RE: PIER INVESTIGATION AND ASSESSMENT RELATIVE TO THE CITY-WIDE PIER REPAIR AND MAINTENANCE PROJECT, CITY OF WEST PALM BEACH, PALM BEACH COUNTY, FLORIDA**

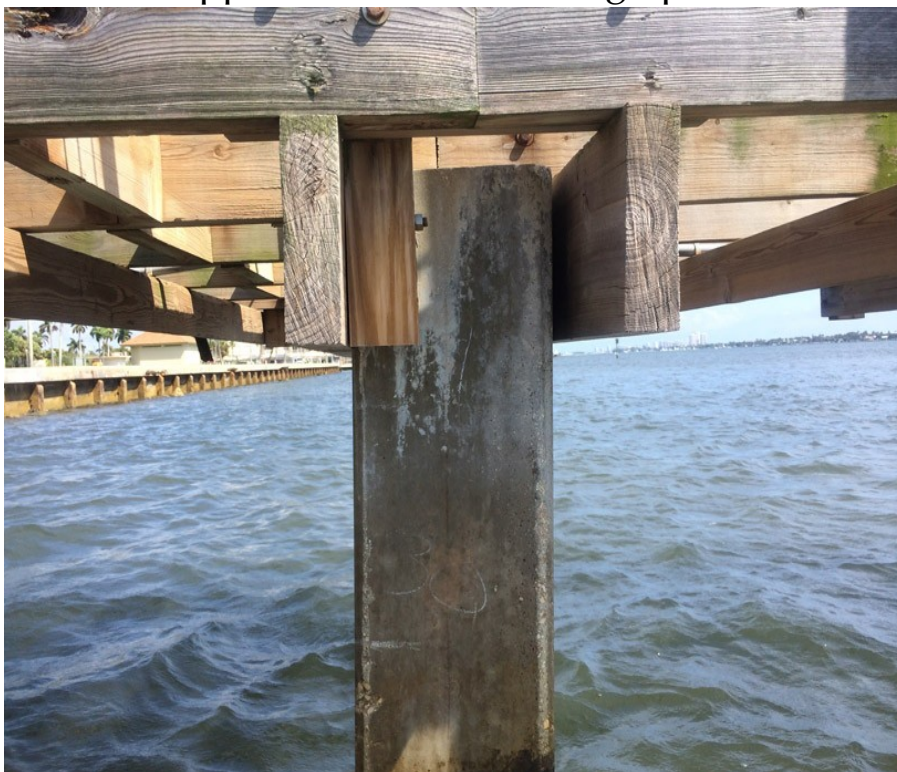
Photo 1: Typical Minor Pile (Pile 4B) - Looking North [Currie Park Pier]

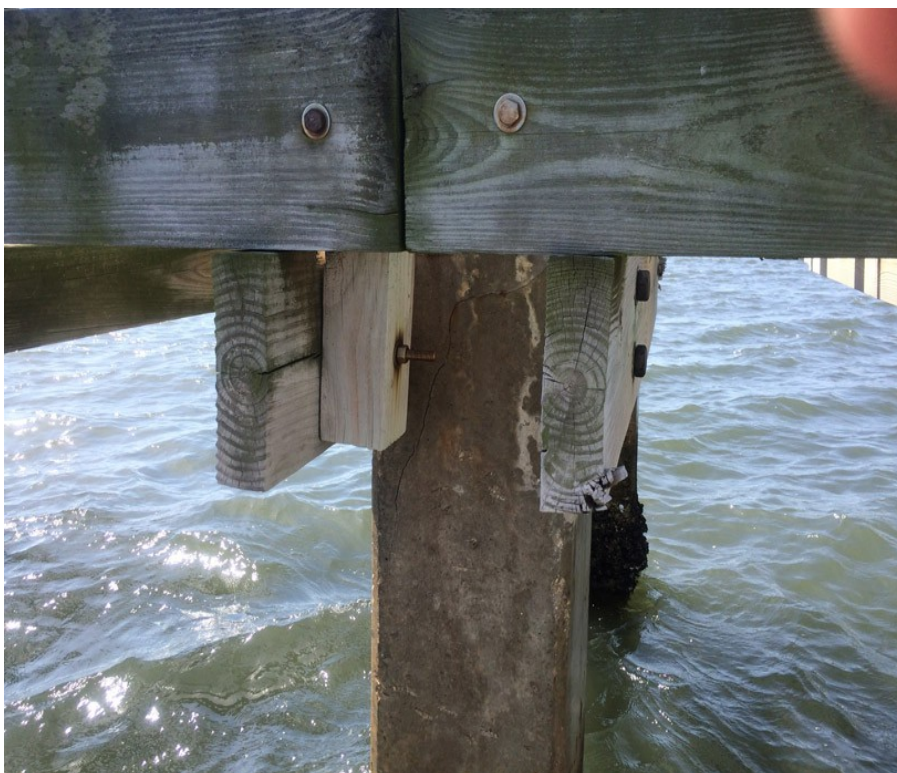
Photo 2: Typical Moderate Pile (Pile 7A) - Looking South [Currie Park Pier]

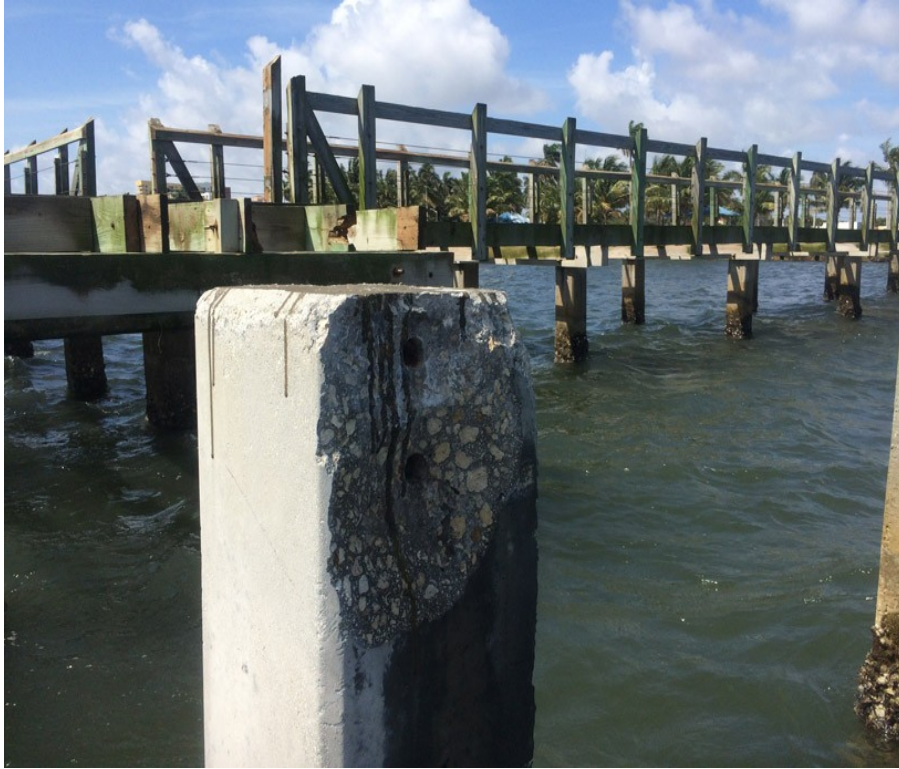
It was observed during the pre-construction meeting on April 1, 2014 with the Client and Contractor that the northeast corner of the pier was damaged and partially collapsed. The plumb pile at the northeastern end of the pier (16A) was observed to have a damaged area at the top of the pile on the north face approximately 12” in height which likely resulted from the vessel impact with the pier superstructure causing an approximate 2” loss of section and reduced bearing capacity.

Photo 3: Typical Advanced Pile ( Pile 16") - Loss of Section from Vessel Impact - Looking Southwest [Currie Park Pier]

Only minor repairs are recommended at this time to address deteriorated areas. In addition to the small, damaged area on the pile at the northeast corner (16A), all exposed cracks and abraded areas on moderate piles (See [Figure 3](#)) should be repaired to restore the original square section and capacity and to prevent further chloride intrusion which would accelerate steel reinforcement corrosion and potential cracking. These crack repairs should be completed with a non-shrink grout for crack widths greater than  $\frac{3}{4}$ " and with a marine-grade epoxy for crack widths less than  $\frac{3}{4}$ ". Based on the current condition of the pier at the Project site, the above recommendation would restore the damaged pile at the northeastern corner to the pre-impact condition and provide protection from future corrosion cracking on the other deteriorated piles. This type of repair would likely extend the service life of the existing concrete piles by 5-10 years. These minor repairs could likely be completed by the Contractor as part of the existing repair and rehabilitation plan for approximately \$2,500 to \$3,500. Also, it would be advantageous for the Client to perform repairs at this time due to the available access allowed by the decking being currently removed. The cost of future repairs when the decking is installed would likely be greater.

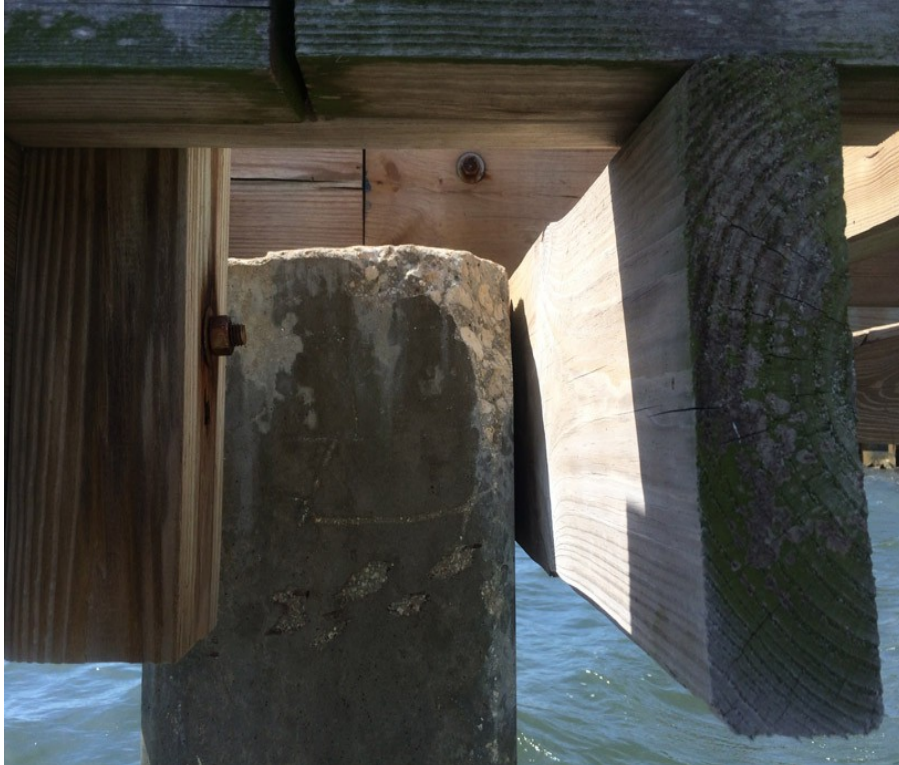
Photo 4: Typical Rounding at Top of Pile (Pile 4B) - Looking South [Currie Park Pier]

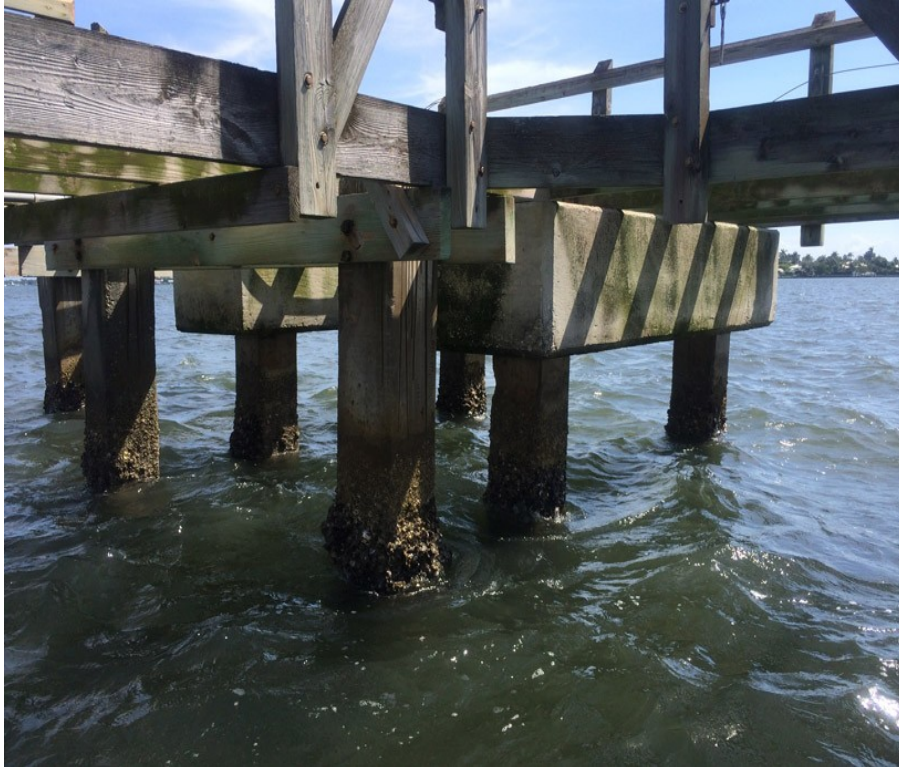
Photo 5: Concrete Pile Caps on T-Head - Looking Northeast  
[Currie Park Pier]

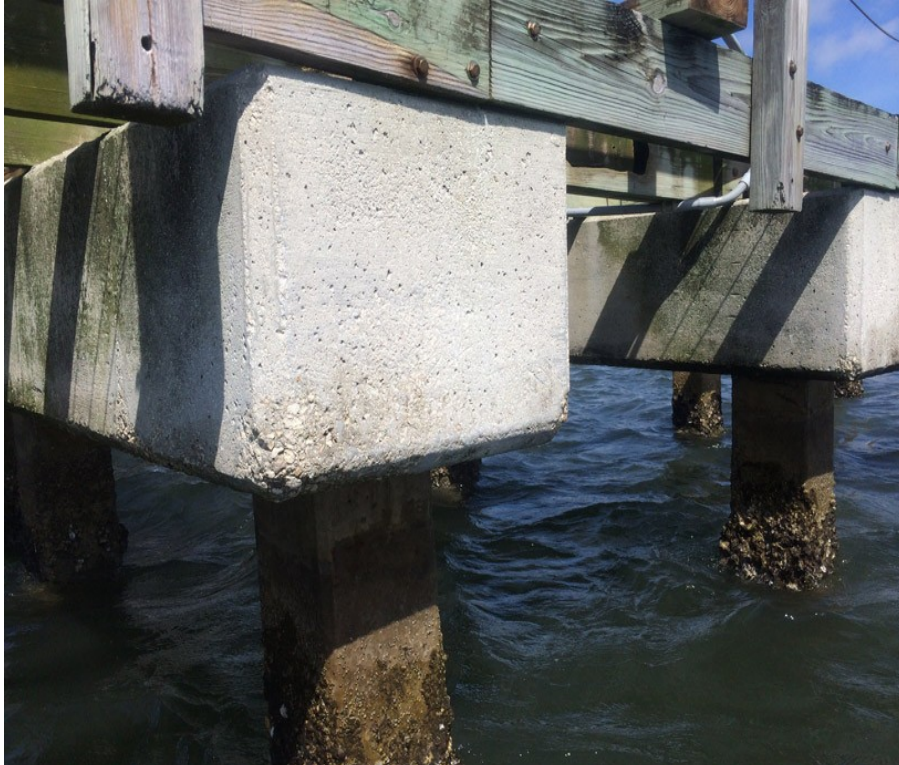
Photo 6: Concrete Pile Caps on T-Head - Looking Northwest  
[Currie Park Pier]

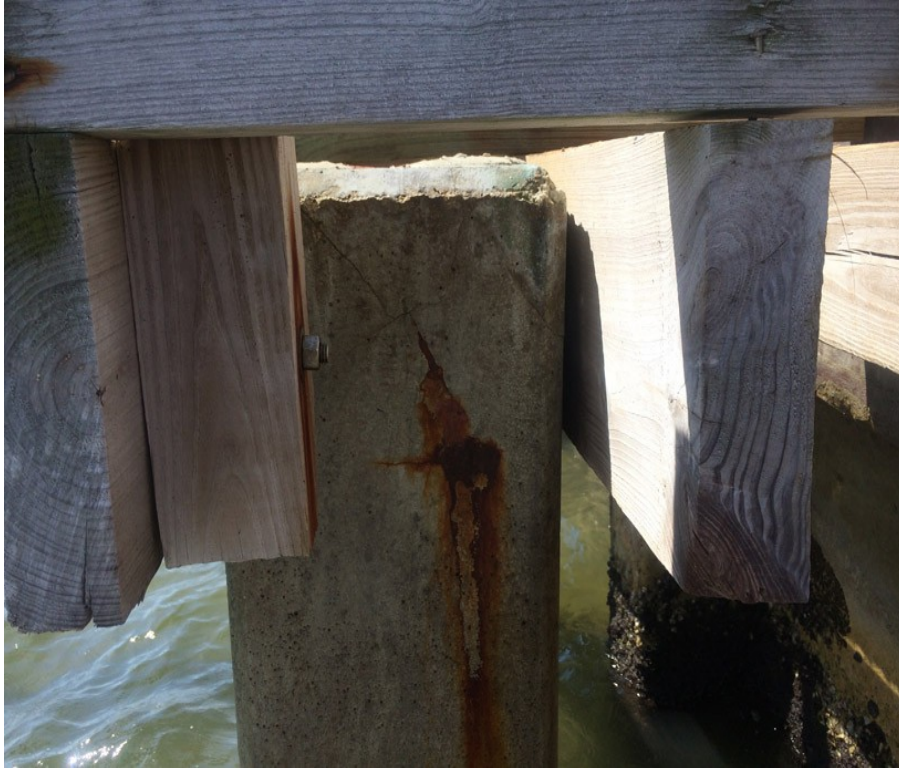
Photo 7: Typical Corrosion Staining on Moderate Pile (Pile 1A) - Looking South [Currie Park Pier]

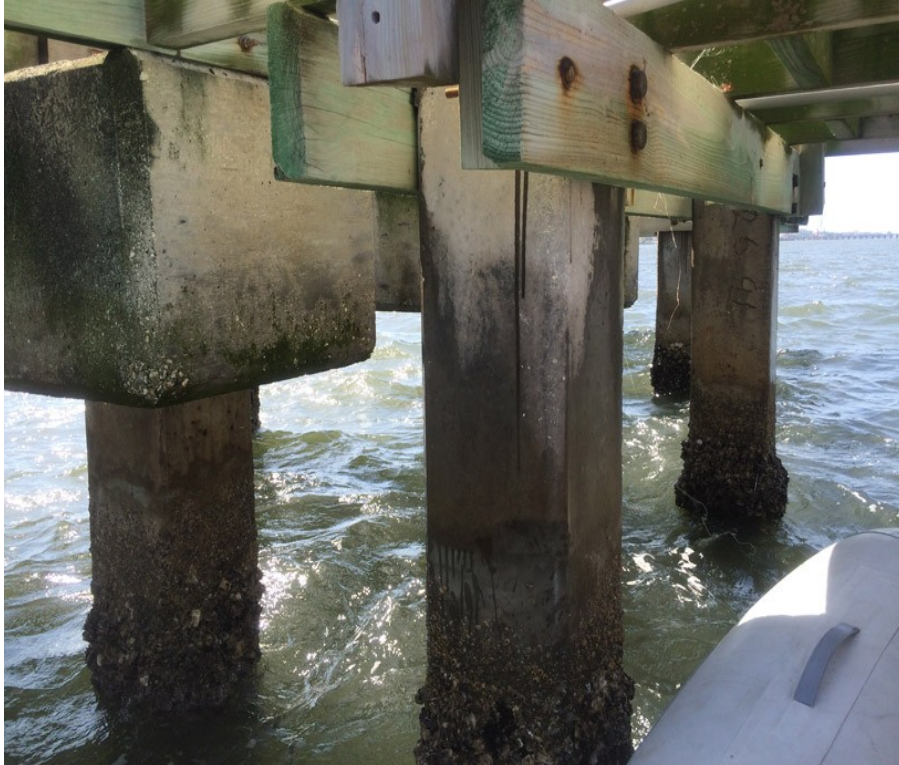
The existing concrete piles appear to be approximately 20 years old based on the current condition of the concrete piles. A review of historic aerials for the site puts the construction of the pier sometime between February 1991 and January 1995. Pile 14D had “4-26-91” etched into the side. Assuming this is the date of manufacture or installation of the pile, this would be consistent with the pier being approximately 23 years old. The concrete piles all exhibited signs of minor deterioration with localized areas of moderate deterioration typical of concrete piles of this age. The size and orientation of the cracks in the top portions of the piles indicate localized overloading from the superstructure connections. The hardness of the concrete indicates minimal chemical deterioration of the piles. The damage caused by the vessel impact to the northeast corner of the pier does not appear to have caused any structural damage (cracking, buckling, displacement, etc.) to the piles in this area beyond the localized damage noted above. The concrete pile caps were observed to have sound concrete and square corners.

Photo 8: Date of Manufacture or Construction "4-26-91" on Pile 15B - Looking Southeast [Currie Park Pier]

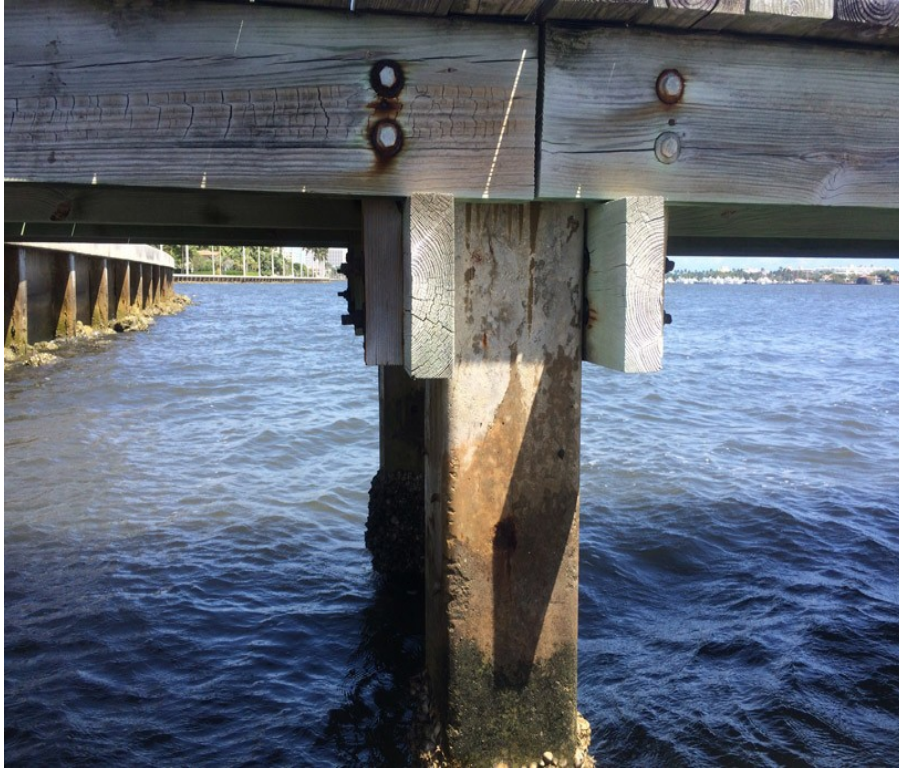
Photo 9: Typical Minor Pile (Pile 2B) - Looking North [El Cid Pier]

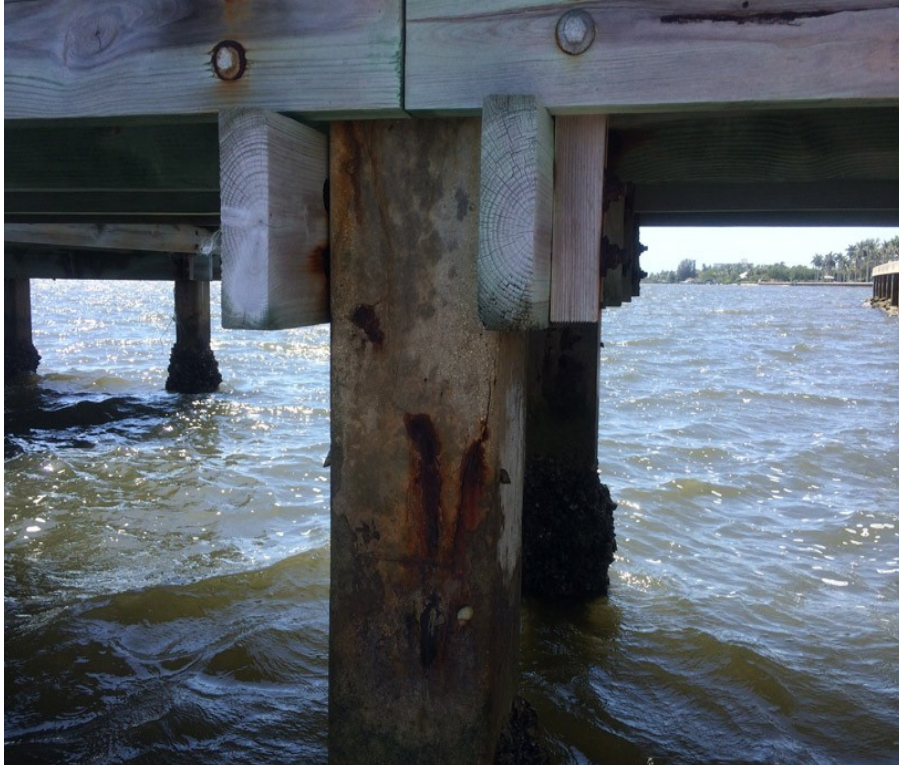
Photo 10: Typical Moderate Pile (Pile 3A) - Looking South [El Cid Pier]

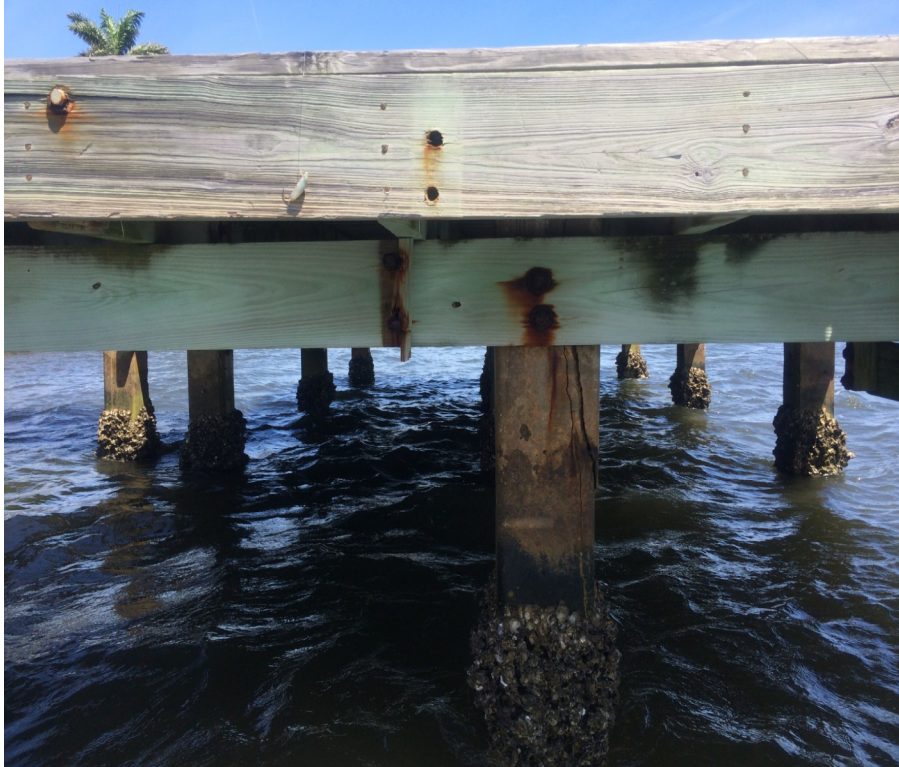
Photo 11: Typical Advanced Pile (Pile 6B') - Looking North [El Cid Pier]

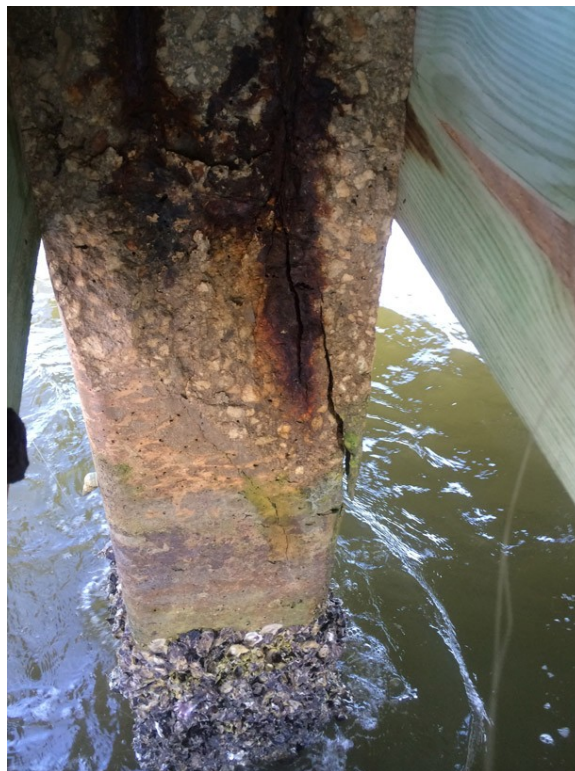
Photo 12: Typical Severe Pile (Pile 6A') - Looking South [El Cid Pier]

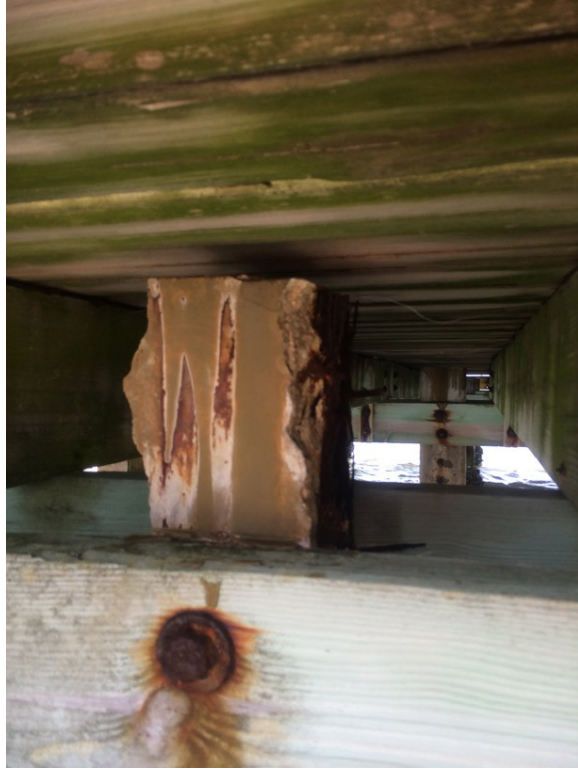
Photo 13: Complete Loss of Concrete Cover with Exposed and Corroded Reinforcement (Pile 6A') - Looking South [El Cid Pier]

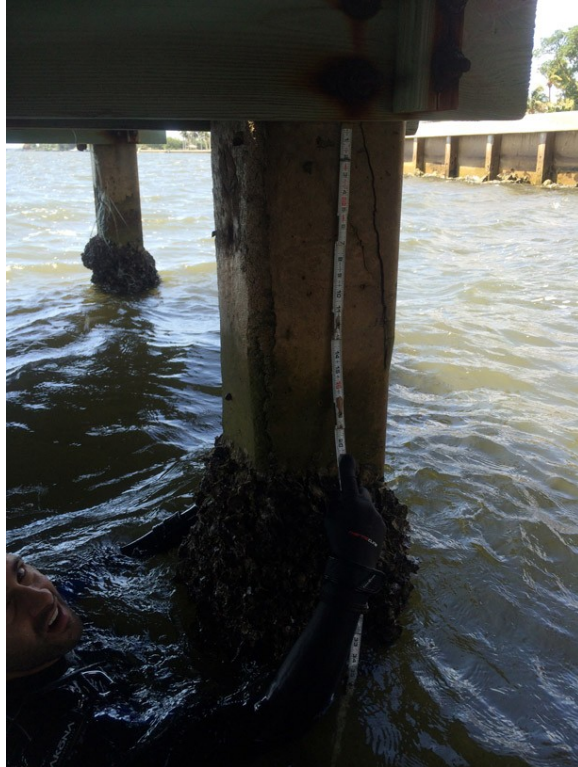
Photo 14: Failure Crack at Top of Pile (Pile 5B) - Looking South [El Cid Pier]

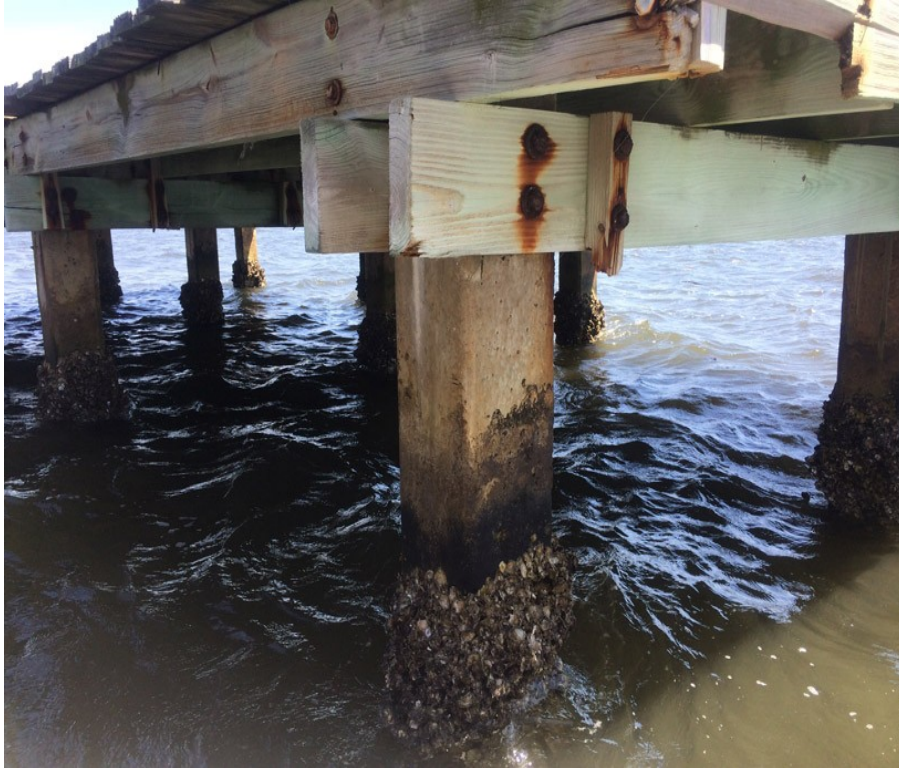
Photo 15: Typical Heavy Marine Growth in Tidal Zone - Looking Northeast [El Cid Pier]

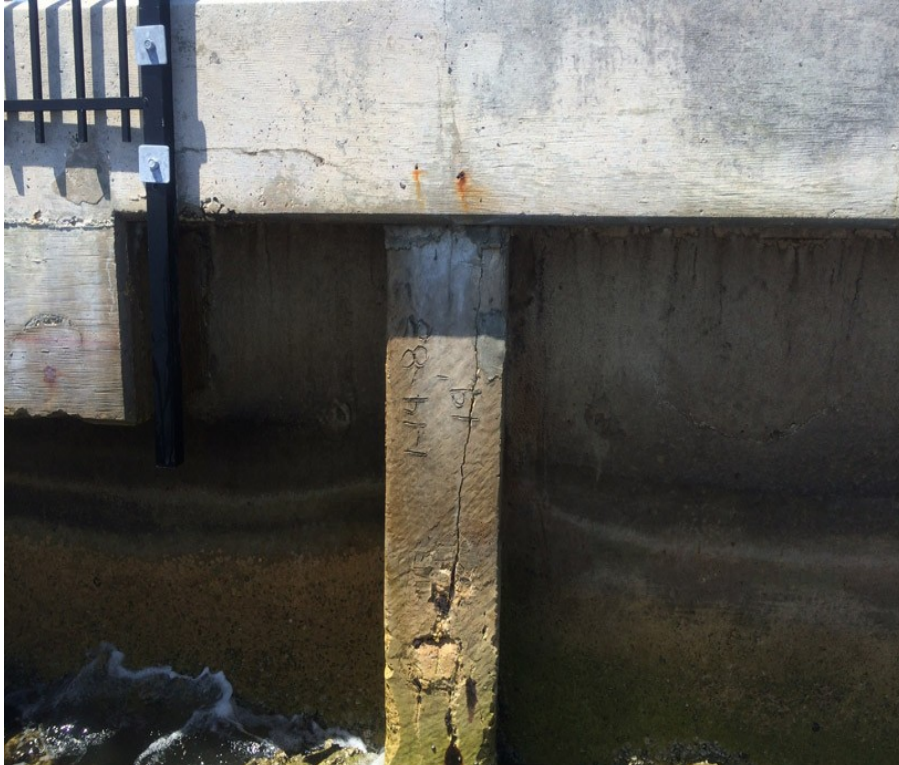
The existing concrete piles appear to be approximately 30 years old based on the condition of the concrete piles. A review of historic aerials for the site indicates a pier located in the same footprint since at least 1958, but the pier has likely been repaired since then. The adjacent pile-panel bulkhead had “1-14-83” etched into one of the king piles. Assuming this is the date of manufacture or installation of the king pile, this would be consistent with the pier being approximately 31 years old. However, the date of construction of the current pier can only be estimated. The concrete piles all exhibited signs of moderate to advanced deterioration with localized areas of severe deterioration. The size and orientation of the cracks in the top portions of the piles indicate localized overloading from the superstructure connections and corrosion cracking. Multiple piles exhibited full plane failures through the entire pile and Pile 6A exhibited complete loss of concrete cover at the top of the pile with exposed, heavily corroded reinforcement. The hardness of the concrete and loss of fascia indicates moderate chemical deterioration of the piles.

Photo 16: Date of Manufacture or Construction "1-14-83" on Adjacent Pile-Panel Bulkhead - Looking West [El Cid Pier]

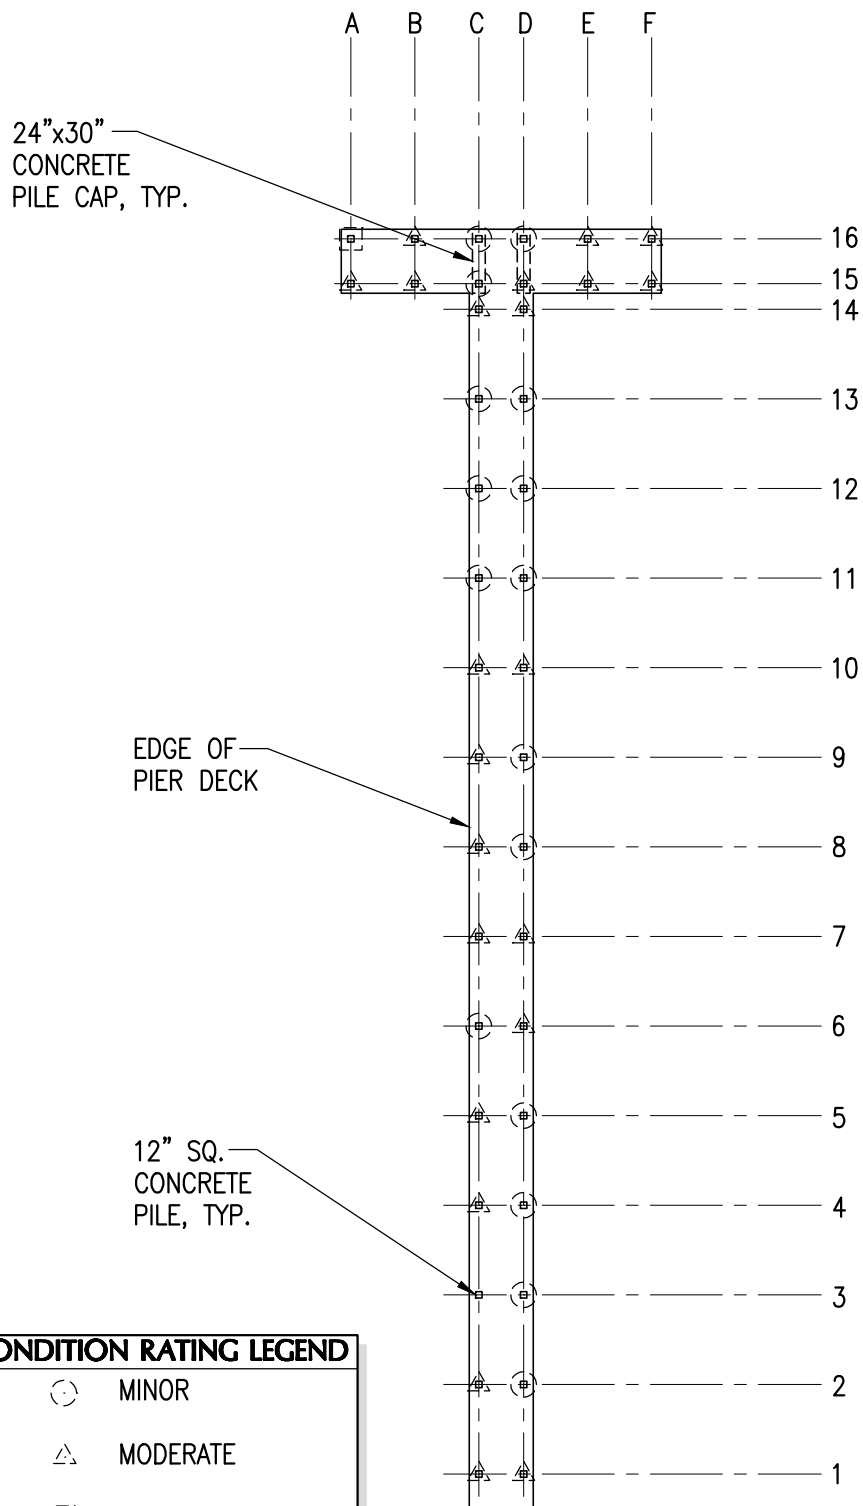
**FIGURE 3**  
EXISTING PILE CONDITION RATINGS  
CURIE PARK – NORTH PIER

Level I evaluations were completed on each plumb pile. Level II evaluations were completed on every fourth plumb pile (approximately 10%). The ratings for each concrete pile are shown in [Figure 3](#). The exposed concrete on each pile was sounded with a masonry hammer at different elevations and appeared to be sound without any “hollow” areas observed. The concrete plumb piles were covered in heavy marine growth; therefore two 12” bands were cleaned using a masonry hammer just below the tidal zone and just above the mudline. Each pile was observed to have minor weathering and shrinkage cracking above the tidal zone. Occasional corrosion stains and spalling was observed at the hardware connection point at the top of the pile. No structural cracks below the tidal zone were observed. Minor, localized concrete patchwork was observed on some piles.

Based on the above noted field observations and criteria established in the ASCE Manual, the substructure (concrete piles and concrete pile caps) is given a rating of **Fair** as all primary structural elements are sound, but minor to moderate defects and/or deterioration was observed. Localized areas of moderate to advanced deterioration were present but do not significantly reduce the load-bearing capacity of the structure. Repairs are recommended, but the priority of the recommended repairs is low.

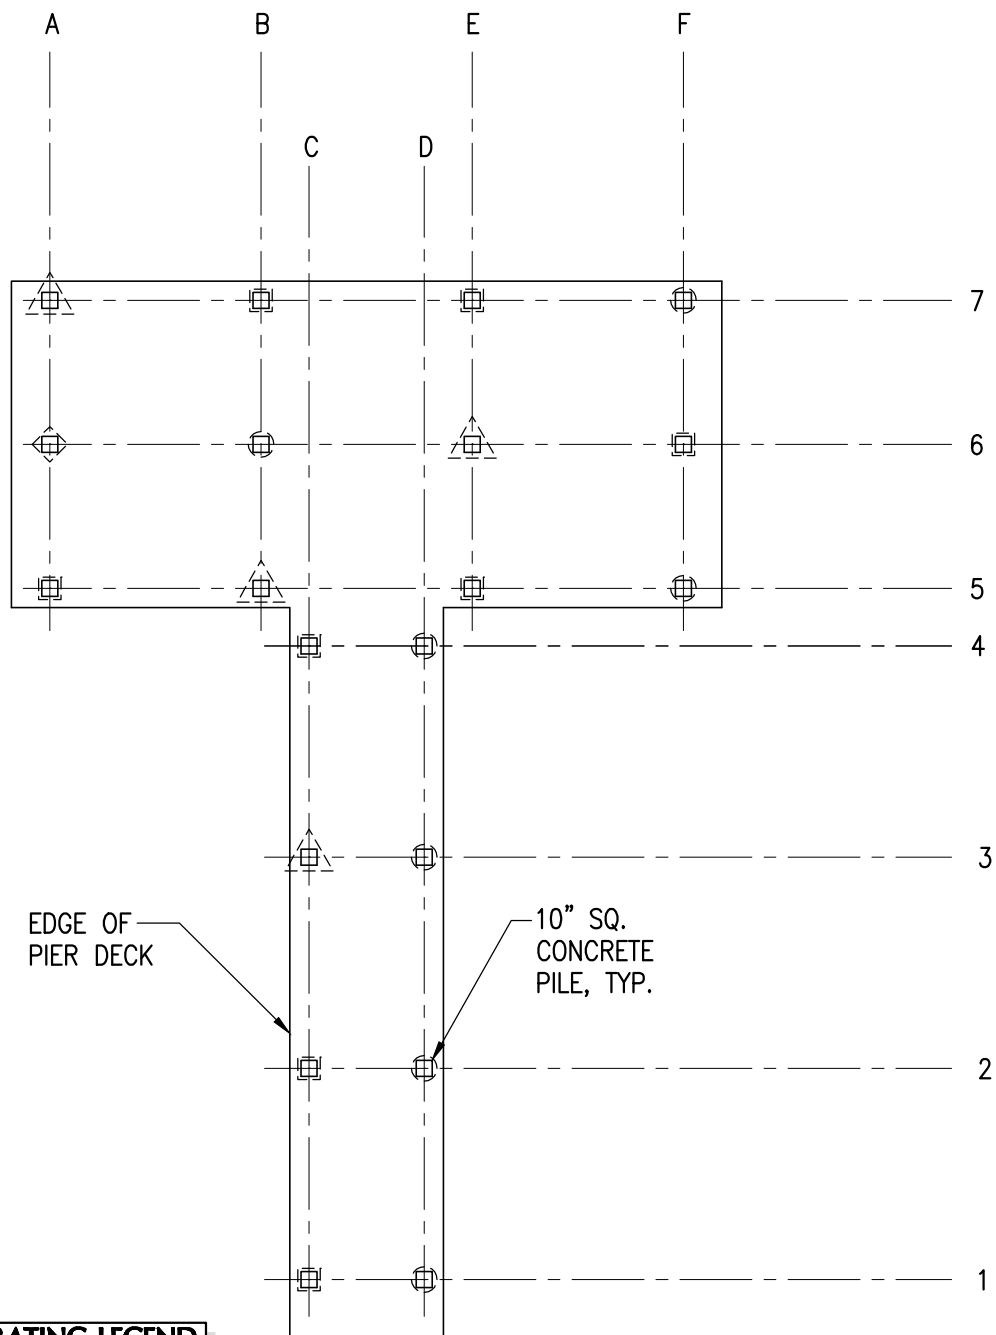
**FIGURE 5**  
EXISTING PILE CONDITION RATINGS  
EL CID PIER

Level I evaluations were completed on each plumb pile. Level II evaluations were completed on every fifth plumb pile (approximately 20%). The ratings for each concrete pile are shown in [Figure 5](#). The exposed concrete on each pile was sounded with a masonry hammer at different

Based on the above noted field observations and criteria established in the ASCE Manual, the substructure (concrete piles) is given a rating of **Poor** as advanced deterioration or overstressing was observed on widespread portions of the structure but does not appear to have significantly reduced the load-bearing capacity of the structure. This is mostly because the majority of existing hardware is through the full section of the pile. However, the existing hardware and timber decking may be preventing further failures and removal of the timber superstructure as

Based on the proposed pier repair and maintenance plan, anticipated live loads, remaining service life, and current condition of the concrete piles, *complete replacement is the recommended approach* for the El Cid Pier. This option would provide a clean surface for the new IPE timber superstructure to be secured to the new piles and provide a properly engineered substructure. Environmental and building permits would be required for this option.

**Pier Option #2 (Repair/Rehabilitation):** In lieu of complete replacement, repair/rehabilitation may be a more economical option for the pier in the short term. All exposed cracks, abraded areas, and failed sections on moderate, advanced, and severe piles (See [Figure 6](#)) should be repaired. This option would require reforming of the deteriorated piles with a marine-grade concrete mortar to restore the original 10"x10" section, cleaning and coating of the corroded reinforcement, and removal of all damaged concrete. Further, all exposed cracks would have to be sealed with a non-shrink grout for crack widths greater than  $\frac{3}{4}$ " and with a marine-grade epoxy for crack widths less than  $\frac{3}{4}$ ". This type of repair would likely extend the service life of the existing concrete piles by 10-15 years. An estimated cost for repair/rehabilitation with this type of repair could range from approximately \$800-\$1000 per pile.
