329502

April 23, 2014

**RE: PIER INVESTIGATION AND ASSESSMENT RELATIVE TO THE CITY-WIDE PIER REPAIR AND MAINTENANCE PROJECT, CITY OF WEST PALM BEACH, PALM BEACH COUNTY, FLORIDA**

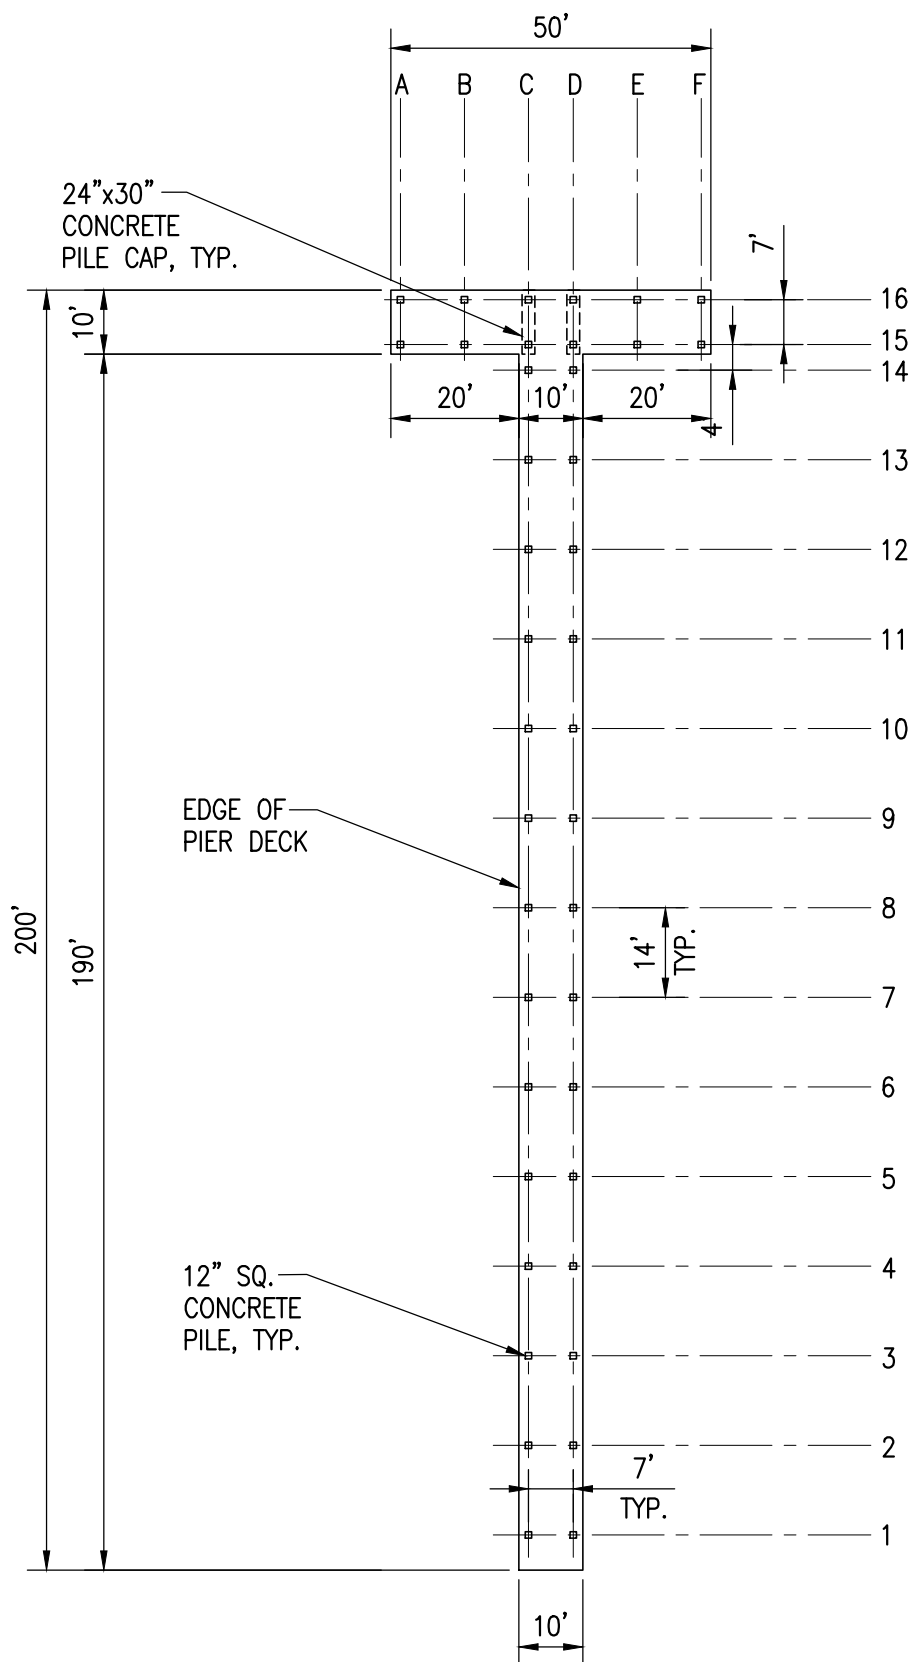
**FIGURE 2**  
EXISTING PILE PLAN  
CURIE PARK – NORTH PIER

The existing pier is a T-shaped configuration extending approximately 200 feet offshore from the existing concrete pile-panel bulkhead. The shore-perpendicular section of the pier is approximately 10 feet wide and 190 feet long. The shore-parallel “head” of the pier is 10 feet wide and 50 feet long. The substructure of the pier consists of 12”x12” precast concrete plumb piles. The pile layout, which shows typical spacing, is shown in [Figure 2](#). At the time of the investigation, the existing pier already had the decking removed by Bayshore Construction, Inc. (Contractor) as part of the initial rehabilitation of the Pier, but timber pile caps, stringers, and railing supports remained. Two concrete pile caps extended between bent 15 and 16 along row A and B. Each pile cap is 24” wide by 30” tall by 10 feet long (in the shore-perpendicular direction).

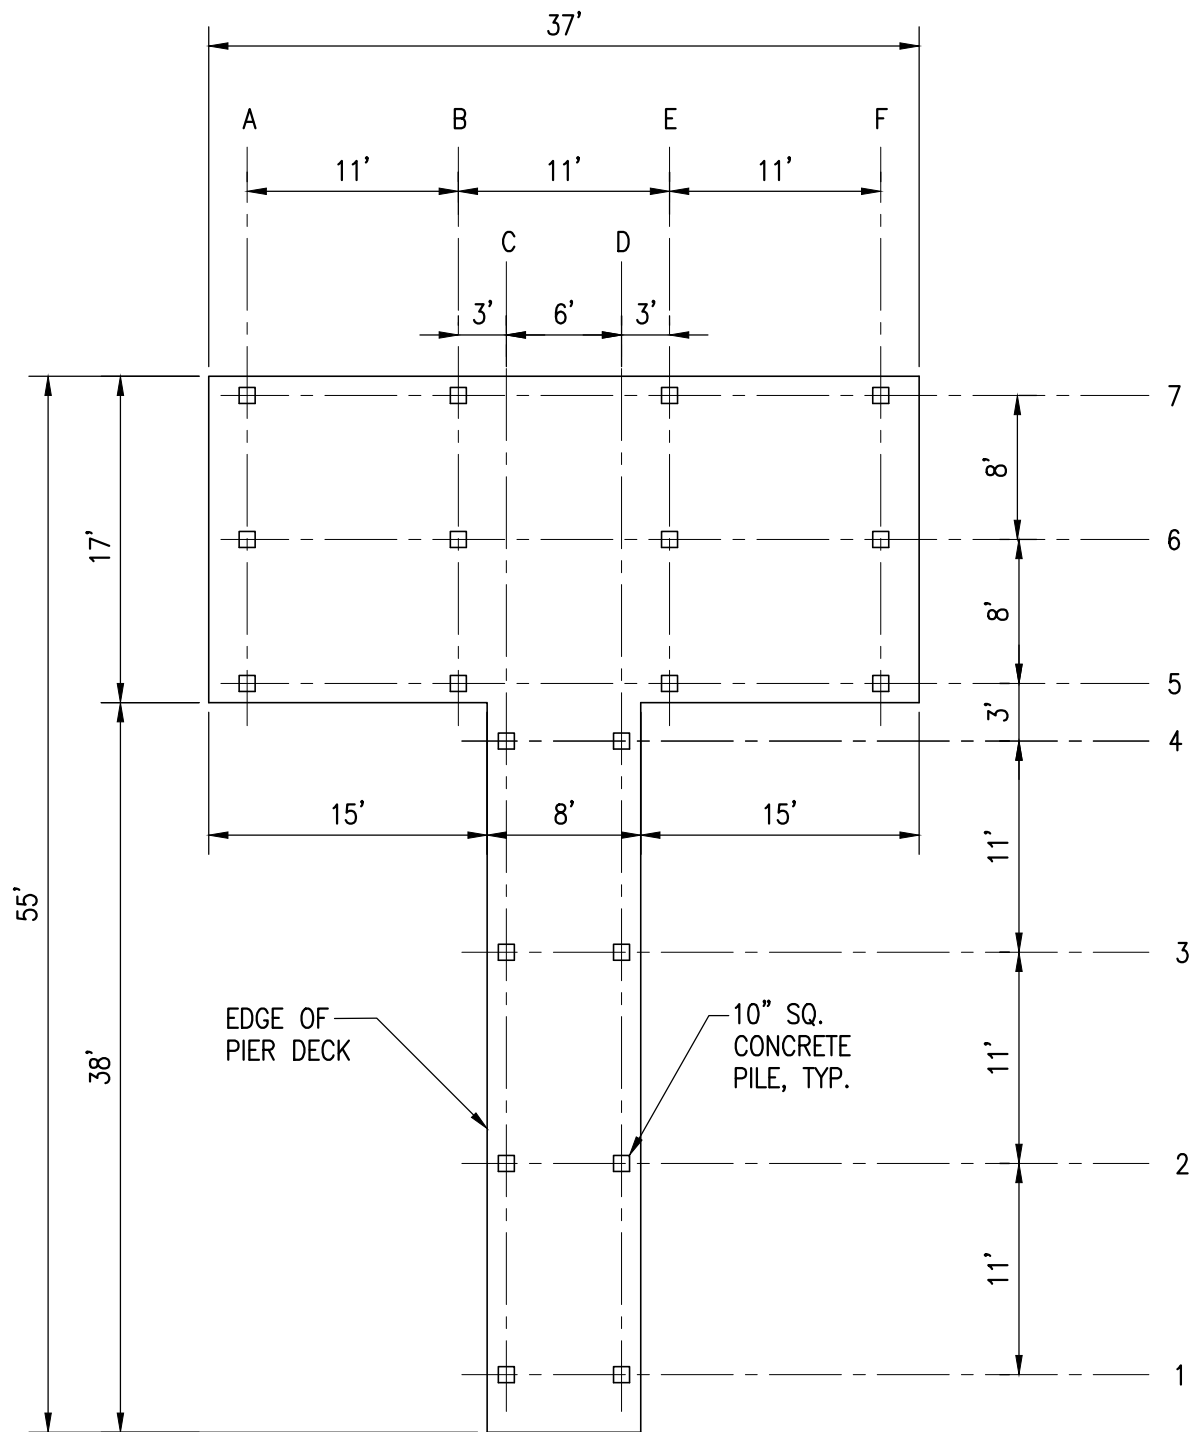
**FIGURE 4**  
EXISTING PILE PLAN  
EL CID PIER

The existing pier is a T-shaped configuration extending approximately 55 feet offshore from the existing concrete pile-panel bulkhead. The shore-perpendicular section of the pier is approximately 8 feet wide and 37 feet long. The shore-parallel "head" of the pier is 17 feet wide and 37 feet long. The substructure of the pier consists of 10"x10" precast concrete plumb piles. The pile layout, which shows typical spacing, is shown in [Figure 4](#). The existing pier consists of timber joists, stringers, decking, and a dilapidated timber ladder at the southeast corner of the structure.
